Earth Dam Failure by Erosion, A Case History

EARTH DAM FAILURE BY EROSION, A CASE HISTORY

In January 1998, the Archusa Creek Dam in southeast Mississippi failed by breaching through its emergency spillway. At the time of its failure, the dam had a concrete ogee weir for a principal spillway and a vegetated earth emergency spillway. Fortunately, the dam is a low hazard structure, as there is little development downstream, and consequences of failure were mostly limited to the loss of a state-owned, recreational water park. The dam failed as a result of a 5-year storm event, triggered by intense rainfall of nearly 4.25 in. in just a few hours. Runoff generated by the storm caused a rapid rise in lake level to elevation above the flood pool, resulting in flow over the emergency spillway. A breach then formed through the emergency spillway due to progressive erosion and head-cutting caused by excessive water flow velocity, a well-known failure mechanism. This paper examines how the failure happened, including the aspects leading up to the breach. Hydrologic, hydraulic, and geotechnical aspects of the failure are discussed, including the dam's design and subsequent modifications, its

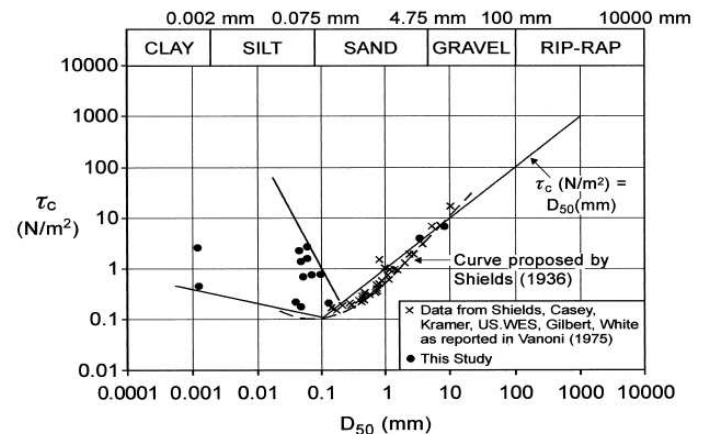
Figure 8 illustrates that the fine silty sand soil within the dam's emergency spillway is generally the most easily eroded soil category and that erosion will result in this soil at a shear stress of about 0.1 N/m², the minimum for all soil types.

Fig. 8. Quantified measure of erodibility—critical shear stress versus mean soil grain size (Seed et al. 2006).

Figure 9 shows that for shear stress above the threshold value for fine sand, 0.1 N/m², a significant scour rate results. For the water velocity imparted to the spillway during the failure storm, exceeding 1.0 m/s, Fig. 8 indicates that the fine sand in the spillway would erode at a rate exceeding 1,000 mm/hr. These values apply to a bare soil not protected by vegetation. Accordingly, the values do not establish specific parameters

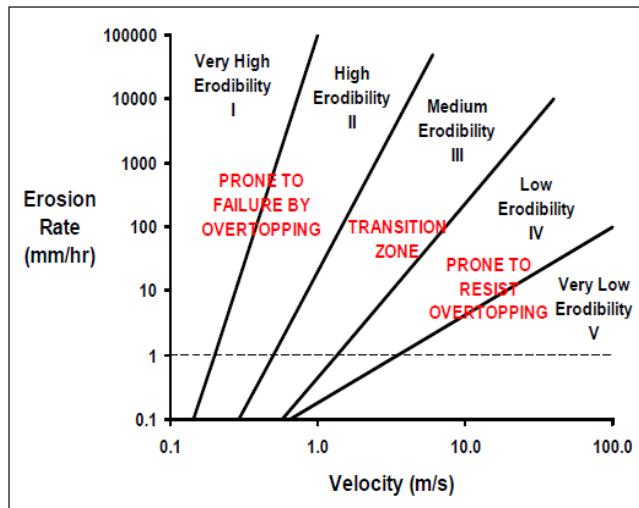
With the expected scour rate over 1,000 mm/hr and velocity imparted to the spillway exceeding 1 m/s, Fig. 10 illustrates that the spillway would have been highly erodible and prone to failure by overtopping. The levee study results depicted in Figs. 8 through 10, combined with the sustainable velocity range portrayed in Fig. 7, explain why erosion resulted in the spillway during the breach storm event.

Fig. 10. Proposed guidelines for levee overtopping (Seed et al. 2006)

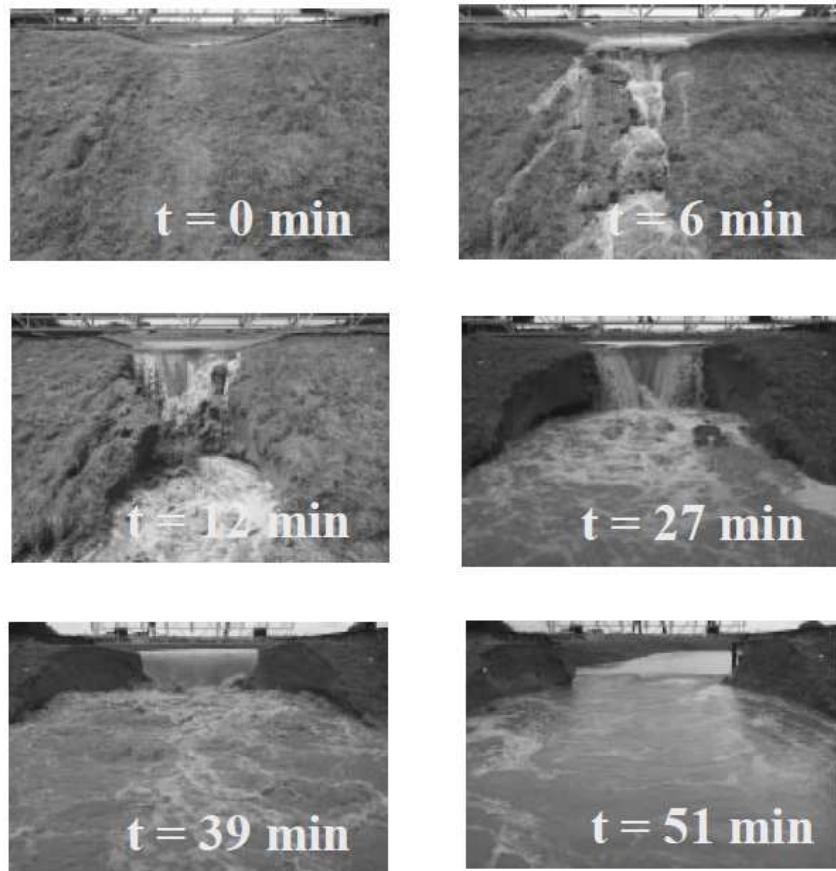
Figure 11 illustrates the three-phase mechanism described above for over-topping failure in earth dams. Failure is initiated by erosion of the soil particles due to excess velocity. A near-vertical face is formed, which travels progressively toward the reservoir during the erosion process (head-cutting). Finally the head-cutting process effects complete breach of the dam.

Fig. 11. Illustration of dam breach by overtopping- embankment breach test of a homogeneous non-plastic sandy soil conducted at the ARS Hydraulic Laboratory, Stillwater, OK (FEMA 2001).

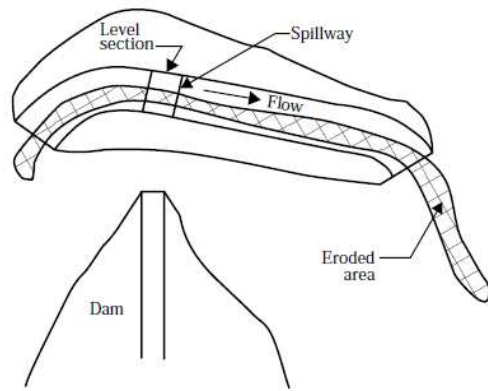
The earthen emergency spillway design for the Archusa Creek Dam did not conform to these criteria. The spillway was located in the middle of the dam, with its bottom in fill where it should have been at an abutment in cut. The spillway did not have a control section sufficient to lower velocity to a sustainable level. Further, the drainage ditch excavated into the spillway concentrated flow and increased velocity, initiating erosion during the failure storm.

Fig. 12. Diagram illustrating proper emergency spillway layout (From NRCS (1997)).

With the emergency spillway out of conformance with these guidelines, erosion was a threat to dam safety. The choice of grass for the emergency spillway lining was inappropriate. Some armored lining, e.g., rip-rap, would be required for the emergency spillway geometry in order to prevent erosion that could result in dam breach.
